***TECHNICAL REPORT ON THE SOIL INVESTIGATION FOR THE  
ARGYLE INTERNATIONAL AIRPORT PROJECT,  
SAINT VINCENT***

**06/09/2006**

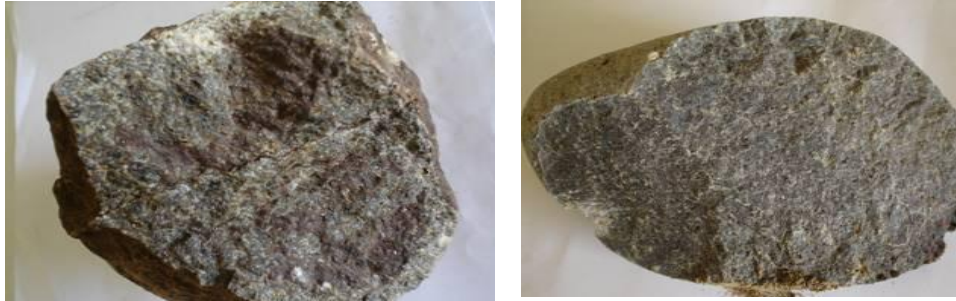
**FIGURES N° 2 and 3.** Basalts of fine texture constituted of numerous irregularly distributed small crystals located in a mass of even finer crystals or glass.

grayish color when meteorized, fine to medium grained, micro/cryptocrystalline texture. In some eruptions the rock is greenish due to the olivine content. Between the observable minerals in the hand samples you have: Plagioclase, augite, amphibole, olivine and glass of a clear coffee color. See figures N° 2 and 3.

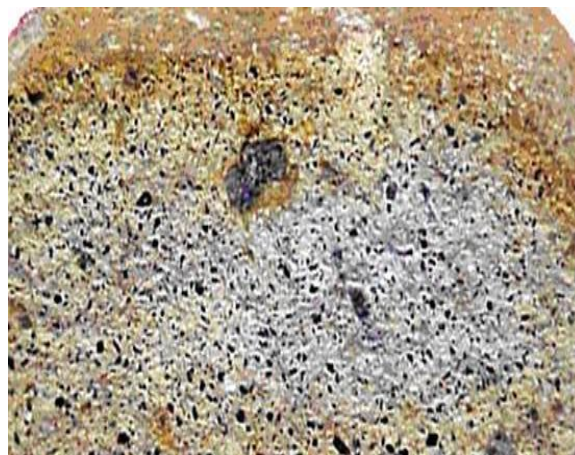
**FIGURE N° 8:** *Pumite showing the vacuoles and its fine texture*

*Rock with very low density and great porosity, permeable, formed by volcanic ash accumulation in an ardent cloud, little consolidated, fine grain, smaller than four millimeters in layers of until 30cm, conditions of decomposed soft rock shows high plasticity and is extremely delineable, difficult to sample as hand sample.*
